QANTAS - Scissor Lift Trucks

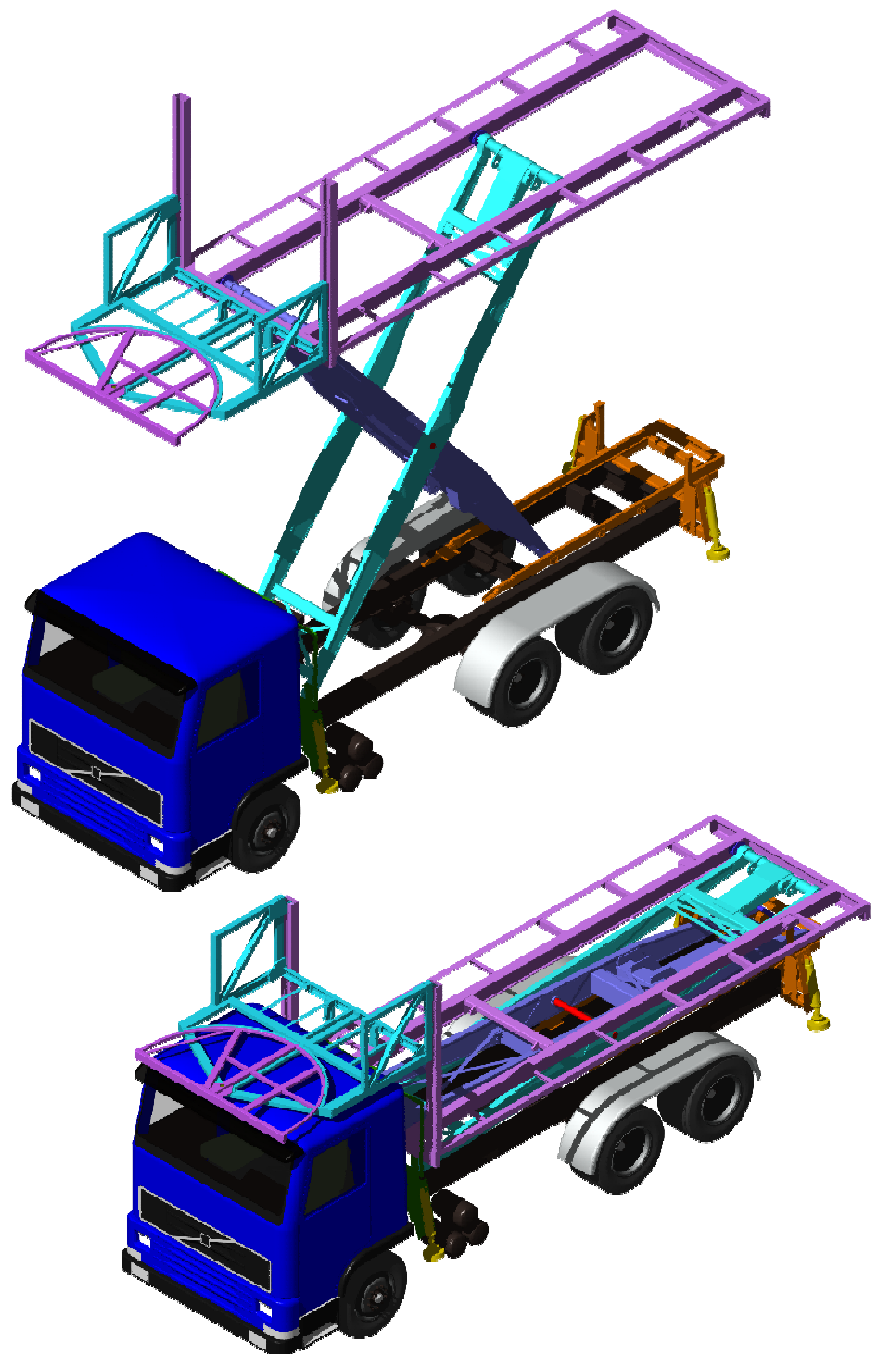
In order to meet the current Worksafe WA requirements, a number of scissor lift trucks required detailed site measurement and thickness testing to allow them to be modelled and drawn in detail (the scissor lift mechanisms and bodies had been manufactured by a variety of companies and no detailed drawings were available to QANTAS).

These models and drawings were then used by a transport specialist engineering company to conduct a detailed engineering analysis to determine their compliance with the current Worksafe WA requirements.
